GAUGLI-ASHUR POLICE STATION
MOSUL, IRAQ

SUSTAINMENT ASSESSMENT

SIGIR PA-06-092
APRIL 26, 2007

Gaugli-Ashur Police Station Renovation Mosul, Iraq

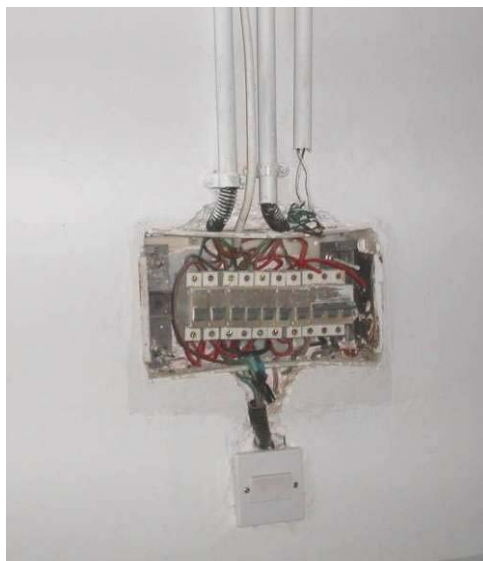
USACE Pre-Construction Photo 1. USACE referred to what a “typical” electrical system need was.

Based on SIGIR's review of the SOW and USACE Pre-Construction Photos, it appeared that the renovation project was reasonably well planned and focused on high priority needs. Requirements included upgrades to the electrical systems and installation of a new back-up generator system (USACE Pre-Construction Photo 1), completion of a detention center previously started (USACE Pre-Construction Photo 2), installation of a heavy metal gate to control access to the area (USACE Pre-Construction Photo 3), construction of rooftop guard houses on the primary building, and complete exterior and interior painting.

The contract's SOW described various requirements related to the overall electrical system. Exposed or damaged wiring needed to be replaced (rewired) and all wiring needed to be securely fastened to walls. As needed, switches, plug-ins, and fluorescent lighting ballasts needed to be installed. Lastly, electric system upgrades included the installation of a new generator with all necessary connections and controls to facilitate automatic conversion to generator power when needed.

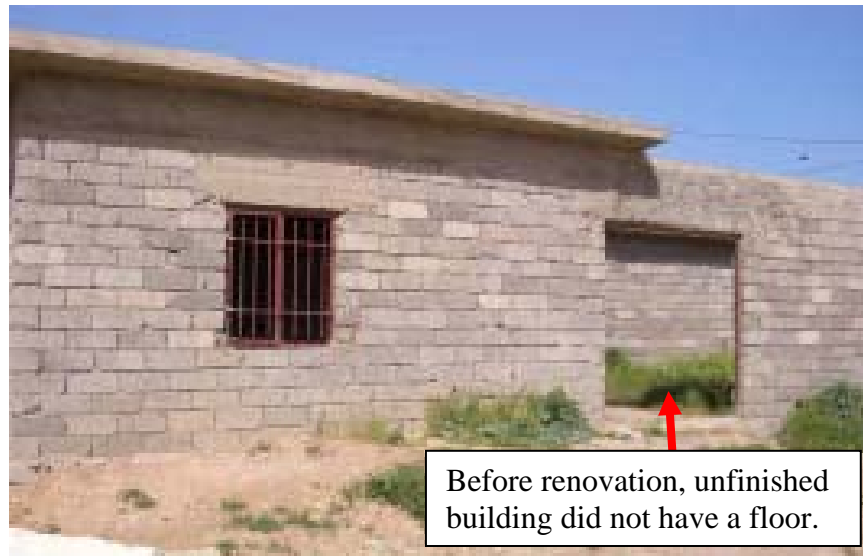
USACE Pre-Construction Photo 2.

The previously started but not finished detention center needed to be completed. Renovation work included installing a floor, detention cell, and steel bars over windows.

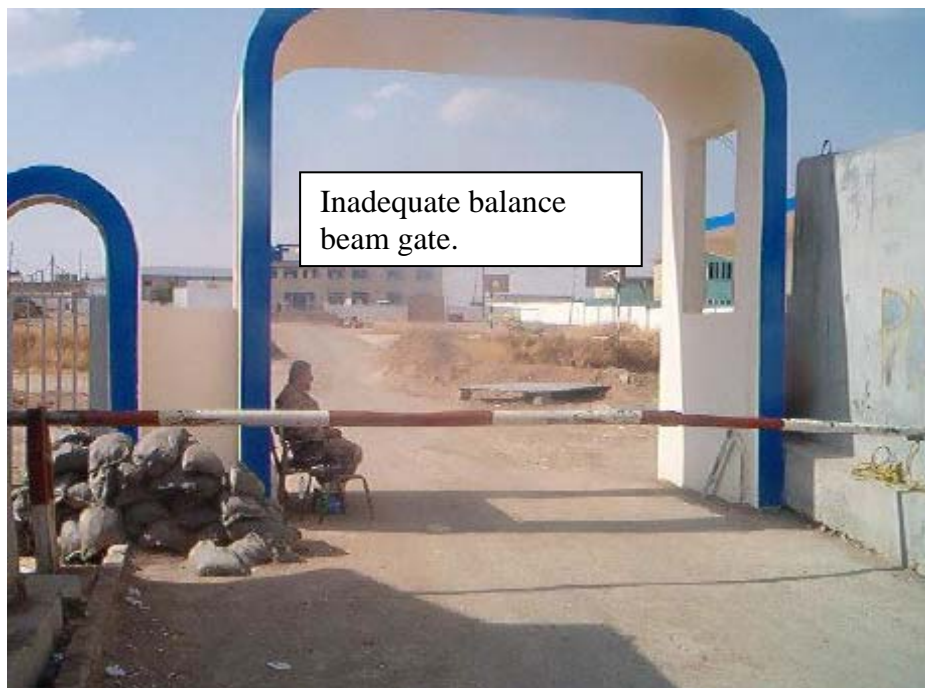
USACE Pre-Construction Photo 3.

Force protection was an important aspect of the renovation project. Accordingly, the SOW included requirements to install a heavy metal gate to prevent unauthorized access to the facility and construct rooftop guard houses. Before renovation, the balance beam gate shown below did not provide adequate security.

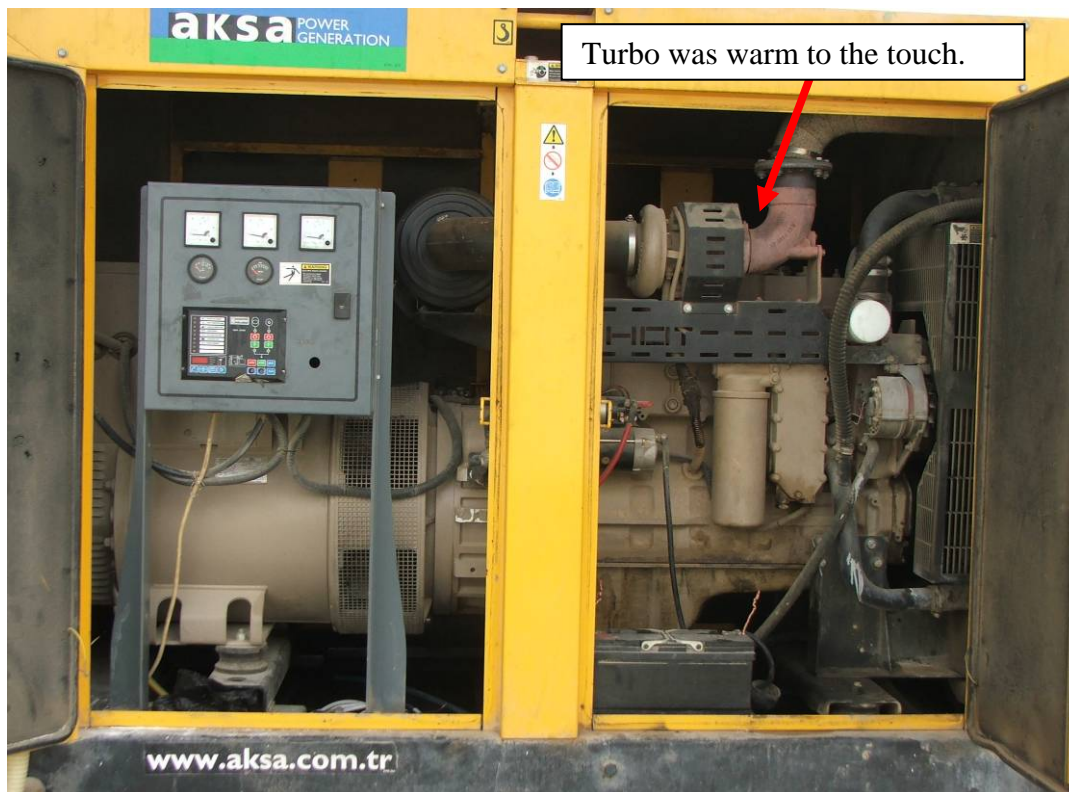
IP personnel stated that the generator and transfer switch system were operational and often used at night. SIGIR verified that the generator's oil level was full and the engine's turbocharger was warm to the touch (Site Photo 1). Accordingly, it was very likely that the generator system had been running the previous night.

Site Photo 1. The generator installed per requirements appeared completely operational without any signs of neglect. When checked, the oil level was full and did not feel gritty. Belts and hoses appeared serviceable.

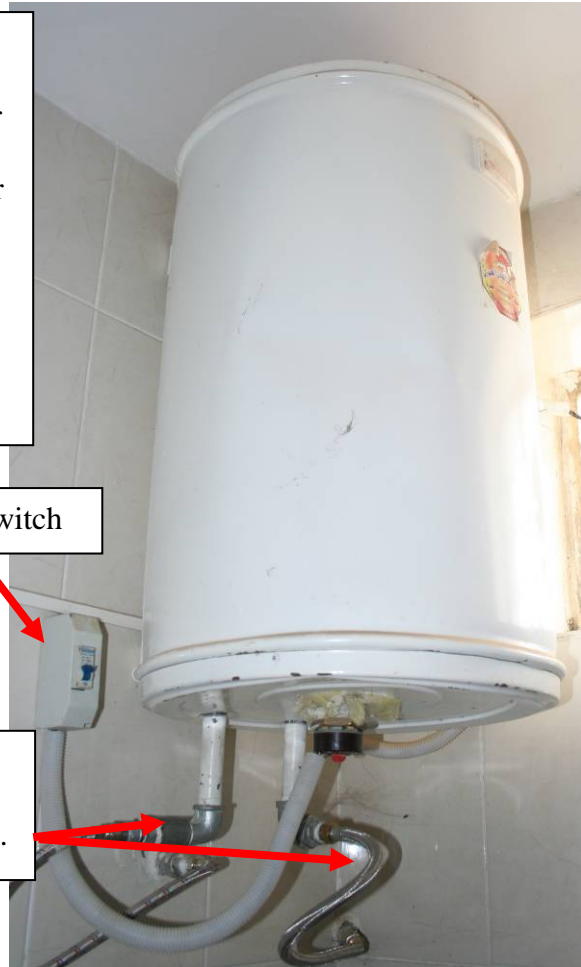
Site Photo 3. Water heater.

Per SOW requirements, improvements included several different water heater installations observed by SIGIR. In all cases, the water heater appeared properly secured, the plumbing and fittings did not leak, and the electric power feed was controlled by a circuit breaker/switch.

Breaker/switch

Metal piping and fittings made for a water tight installation.

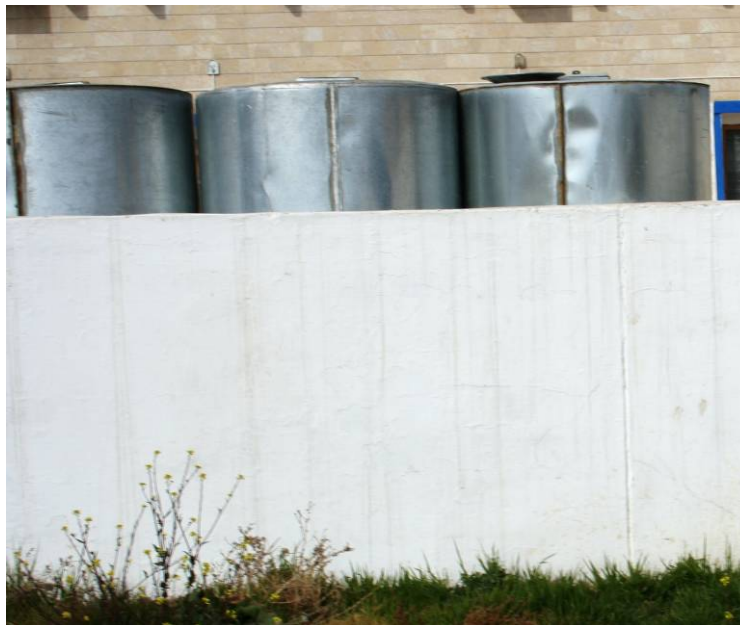
Site Photo 4. Throughout the facility, SIGIR observed new water storage tanks to meet SOW requirements to provide adequate supply.

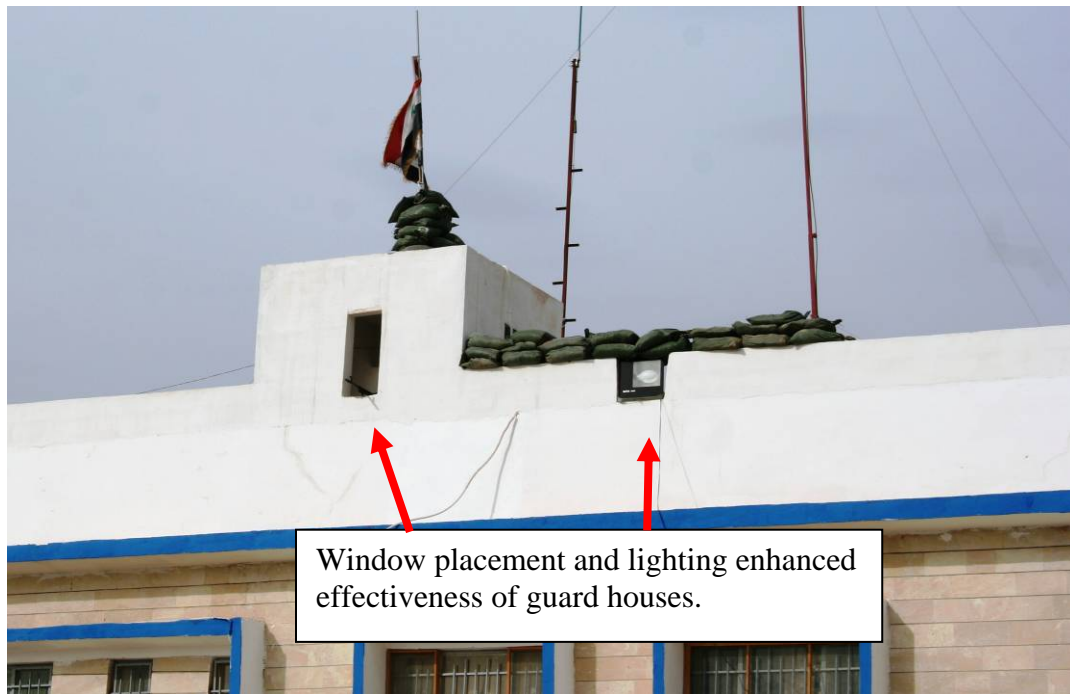
Site Photo 5. As required, new rooftop guard houses and lighting upgrades improved force protection capability.

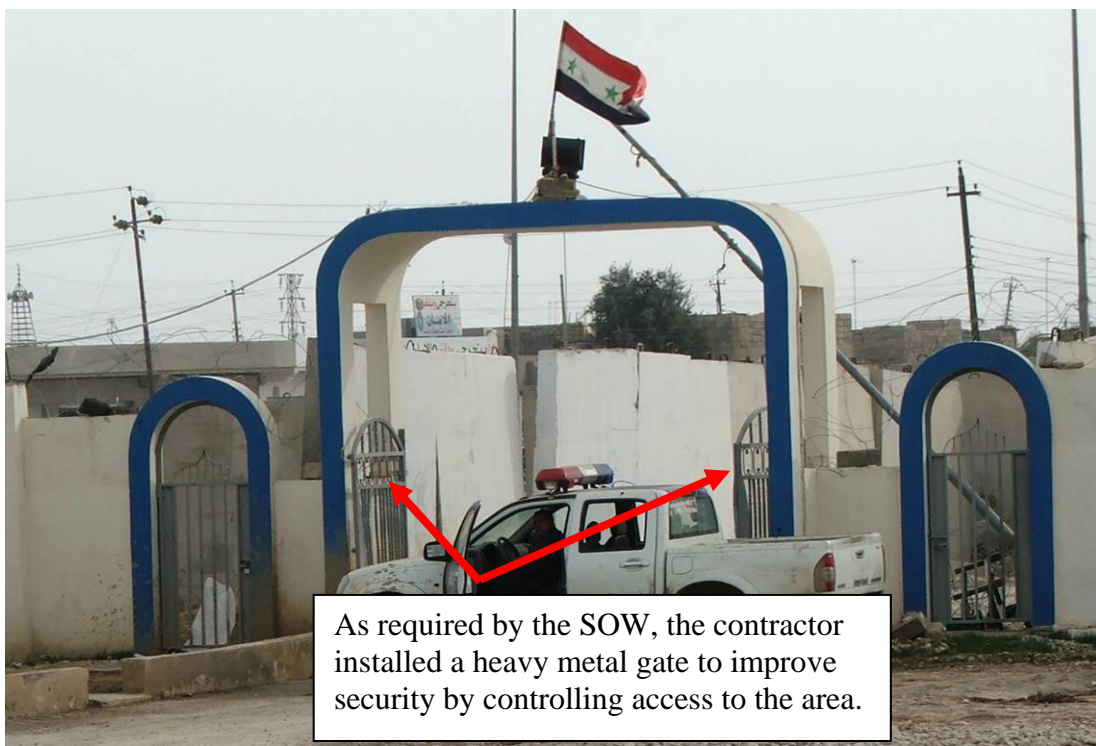
Site Photo 6. Heavy metal gate.

attacked (Site Photo 5) and a heavy gate to control access to the area was installed by the contractor to meet SOW requirements (Site Photo 6). Lastly, SIGIR observed the detention center was functional and in use (Site Photo 7).
